# Disaster Management Programs for Historic Sites

Dirk H.R. Spennemann  
David W. Look

Proceedings of a symposium organized by the U.S. National Park Service, Western  
Regional Office, San Francisco, in collaboration with the Western Chapter of the  
Association for Preservation Technology, and held June 27-29, 1997 in San Francisco.  
Includes bibliographical references and index.

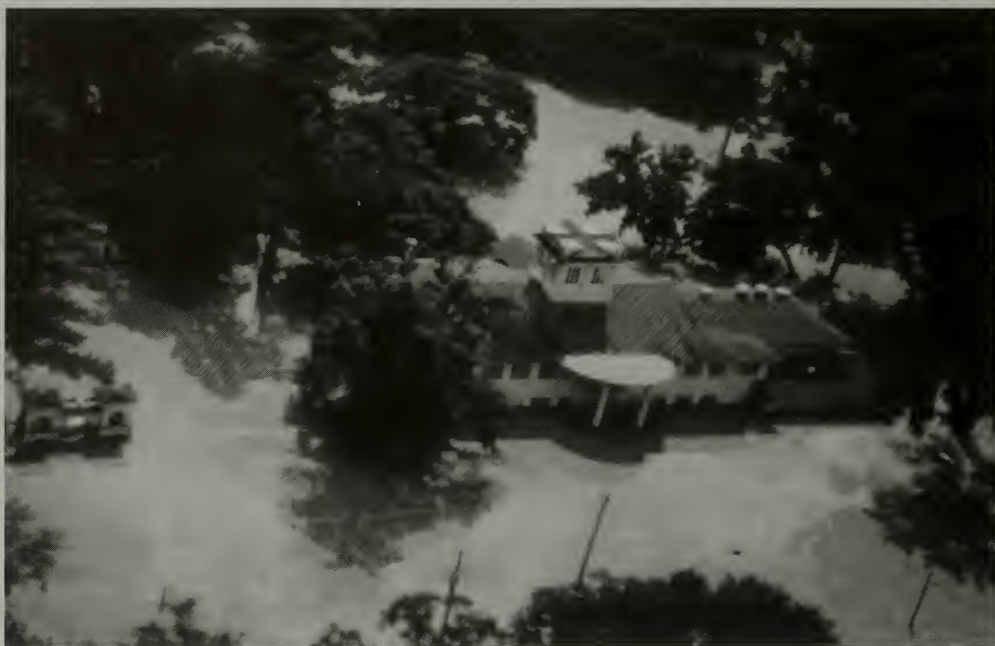
**Figure 20.1. Aerial view of the 1920s Radium Springs Casino, Albany, Georgia, inundated by floods in July 1994. (Photo: Jim Lockhart 1994).**

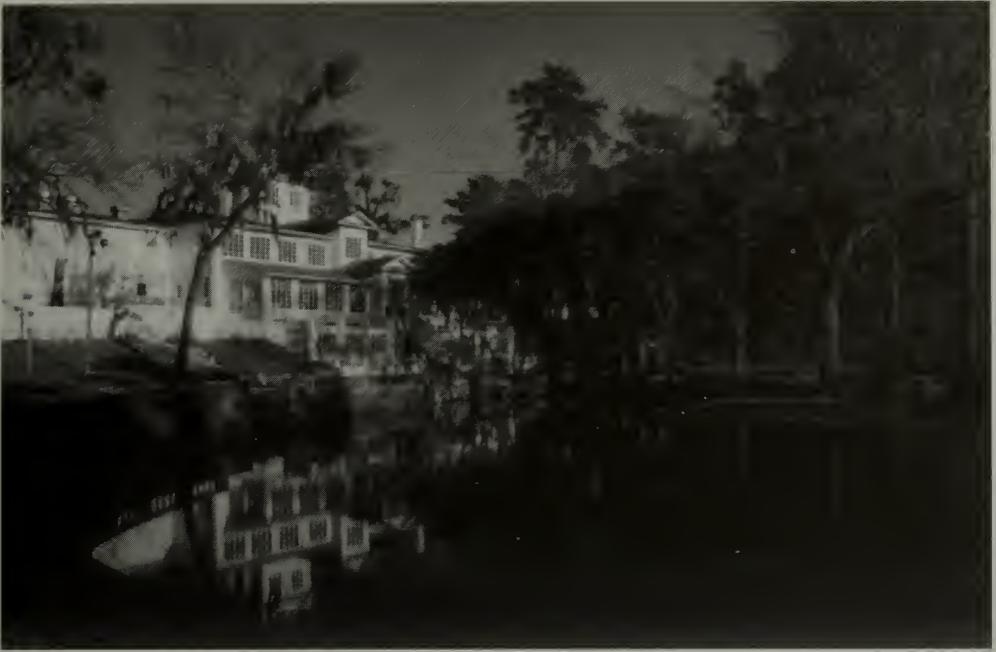
**Figure 20.2.** The Radium Springs Casino in 1996, following the restoration. A US\$ 57,000 grant by the Georgia Historic Preservation Division assisted in the recovery (Photo: Jim Lockhart 1996).

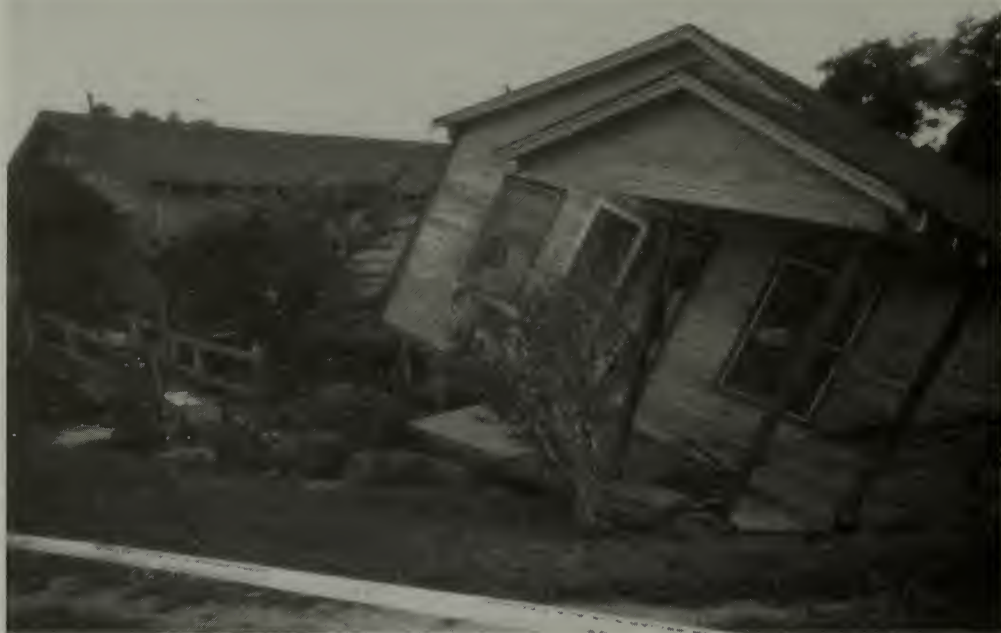
**Figure 20.3.** Historic home in Albany, Georgia, following Tropical Storm Alberto in July 1994. The flood waters washed out part of the foundation all causing the collapse of the wooden structure (Photo: Jim Lockhart 1996).

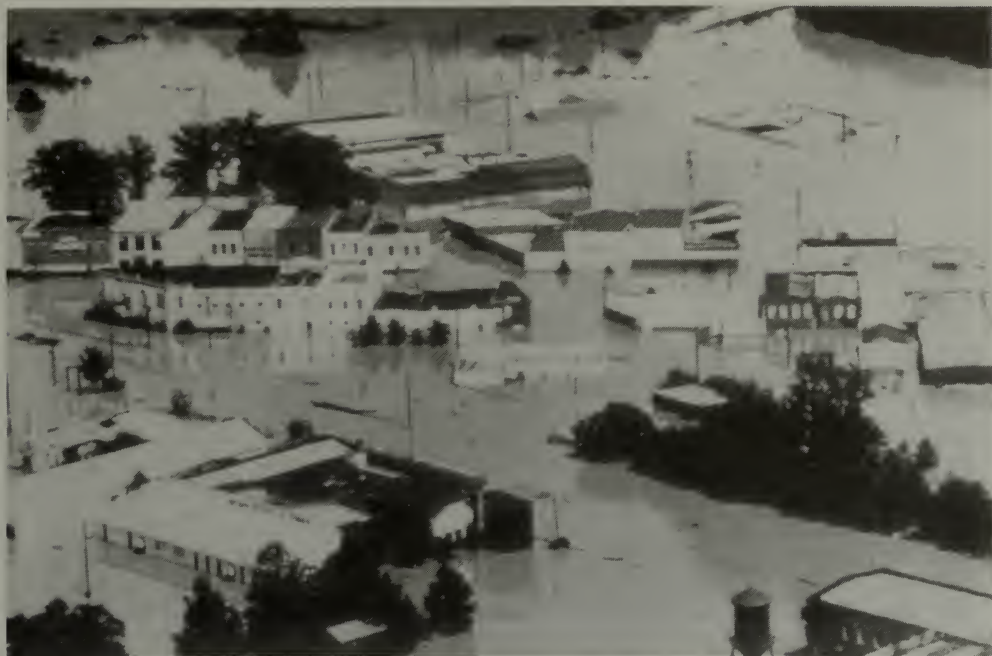
**Figure 20.4.** Aerial view of the Commercial Area of downtown Montezuma, Georgia, inundated by floods following Tropical Storm Alberto in July 1994. (Photo: Jim Lockhart 1996).

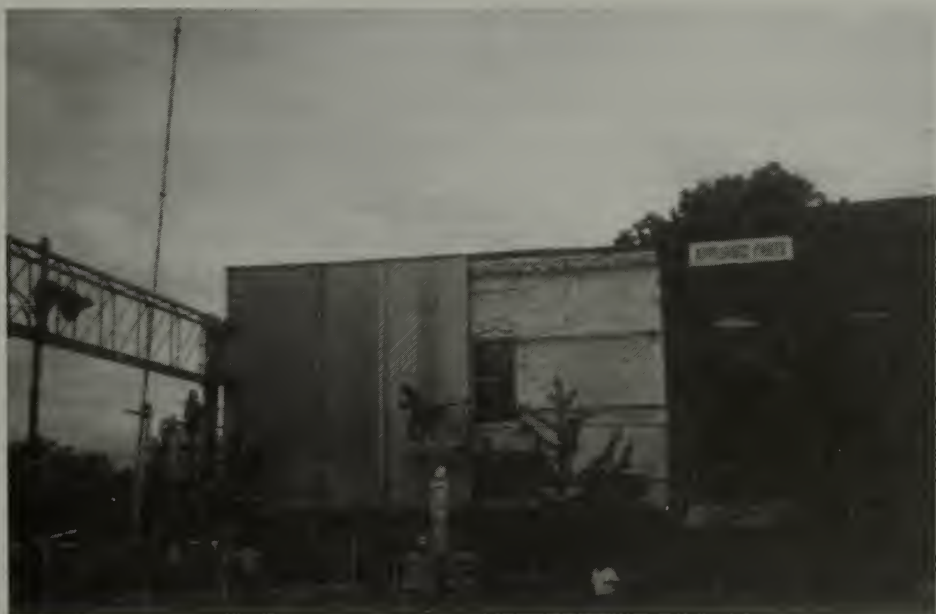
**Figure 20.5.** Conservation management action following the flooding of Montezuma, Georgia, allowed the rehabilitation of the damaged structures. A façade rehabilitation block grant allowed the restoration of historic structures and the removal of metal slipcover on commercial buildings. (Photo: Jim Lockhart 1996).

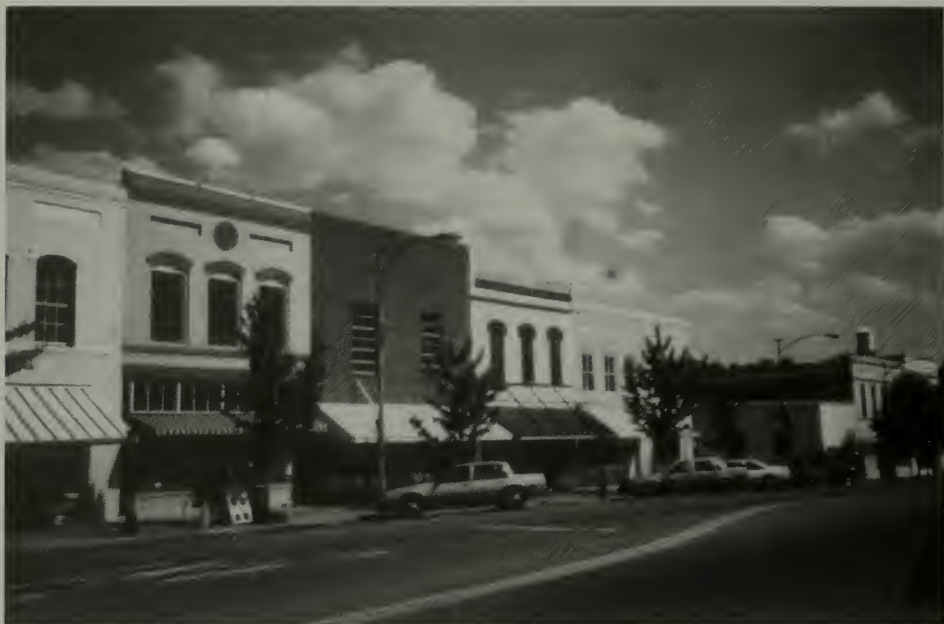
**Figure 20.6.** Following the flooding by Tropical Storm Alberto of Montezuma, Georgia, the city was the recipient of a US\$ 600,000 Flood Recovery Grant to rehabilitate over 40 commercial buildings. (Photo: Jim Lockhart 1997).

All of this activity in Montezuma is a result of flood recovery efforts. This town is an example of how preservation benefits flood recovery, and how Georgia's Historic Preservation Division recovery program is succeeding.

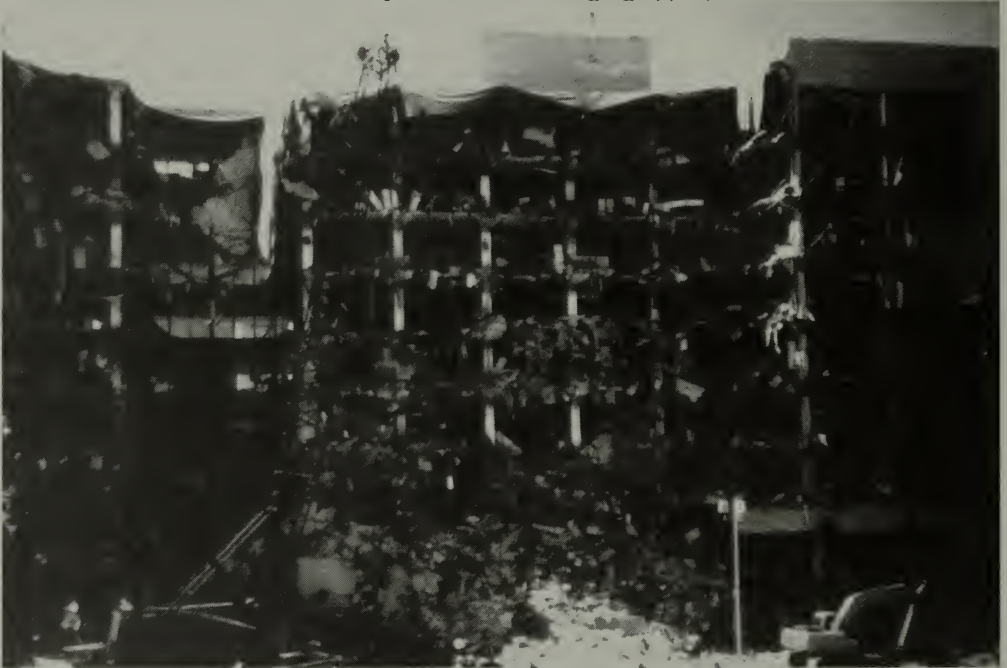
**Figure #.1 The Alfred P. Murrah Federal Building after the bombing on 19 April 1995**

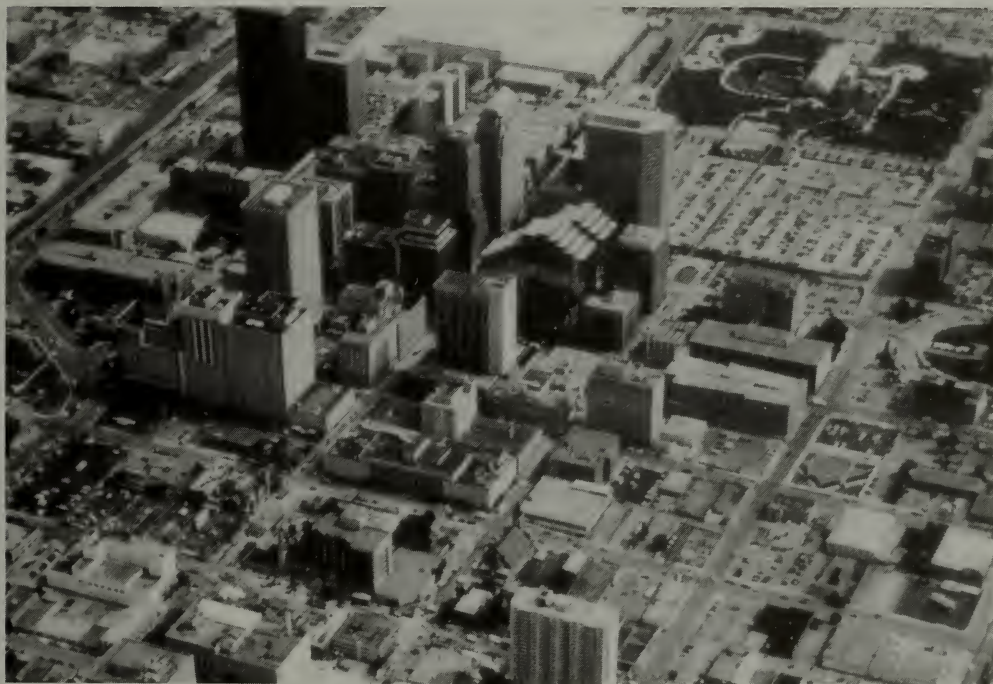
**Figure #.2.** The city center of Oklahoma City after the bombing. The Alfred P. Murrah Federal Building is located in the left foreground.

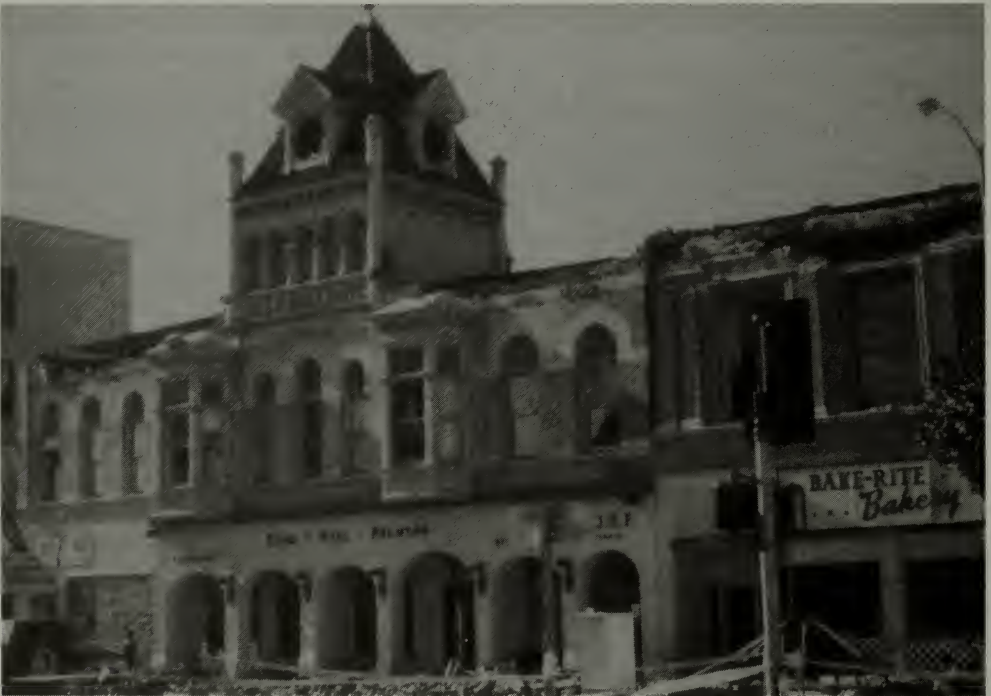
Figure 24.2. A case of retribution. The Oddfellows Fraternal Hall, Watsonville, CA, was damaged during the 1989 Loma Prieta earthquake, the falling parapet masonry killing a pedestrian. Although repairable, the building was quickly demolished a few days after the disaster. The tower is a wood frame construction with metal covering and did not fail during the earthquake event. (Photo: Steade Craig 1989).
